Home Inspection Report

February 17, 2011

RE: 1234 Port Royal Avenue
Waldorf, Maryland 20602
Inspection #: 272-033011-0543

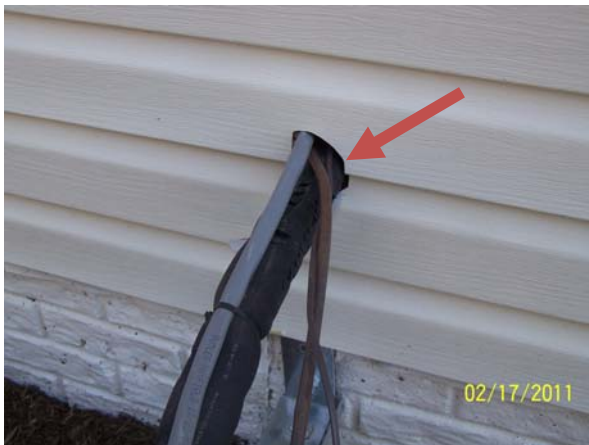
Figure #1

The area where the A/C lines enter the home was not sealed. We recommend having this area sealed.

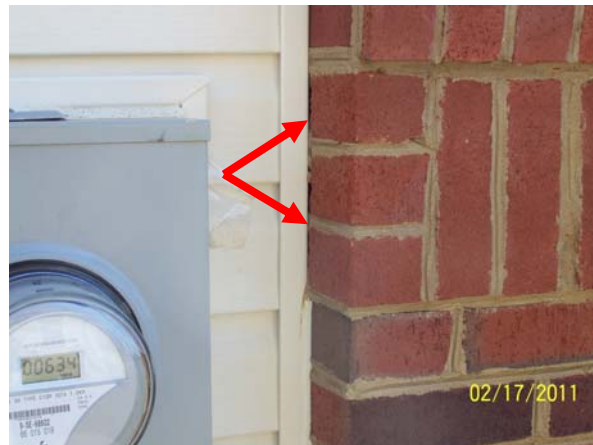
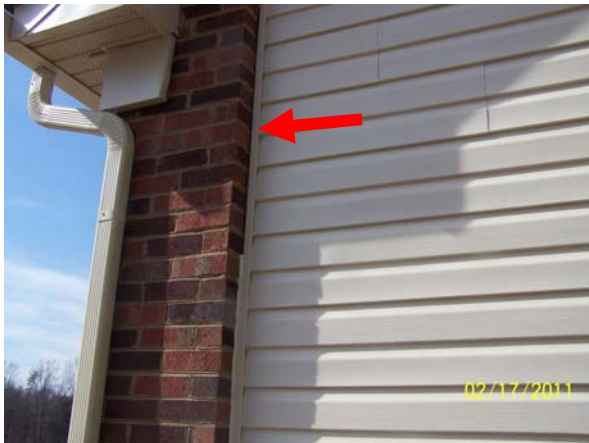
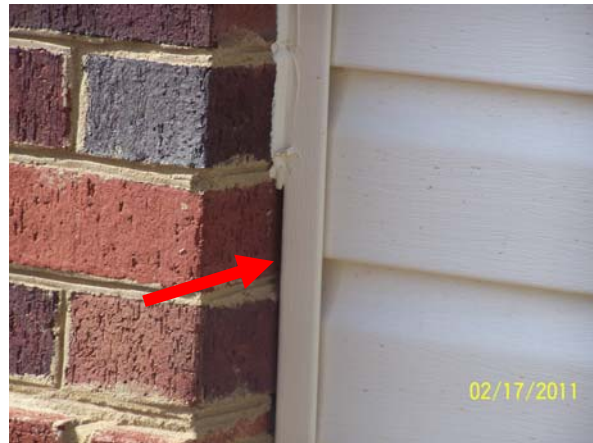
Caulking was missing at both sides of the home where the brick and vinyl join. We recommend having these areas caulked.

- The area where the A/C lines enter the home was not sealed. We recommend having this area sealed. See Figure #1
- Caulking was missing at both sides of the home where the brick and vinyl join. We recommend having these areas caulked. See Figures #2-4

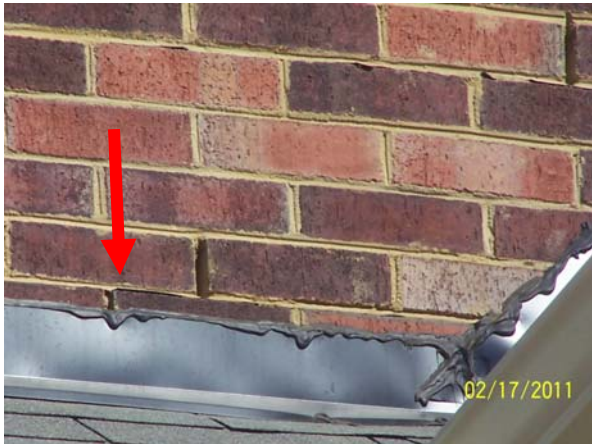
There was a weeping hole in line with the flashing at the front of the home. This condition may allow rain water to seep behind the flashing. We recommend consulting a licensed roofing contractor to evaluate and correct as needed.

- There was a weeping hole in line with the flashing at the front of the home. This condition may allow rain water to seep behind the flashing. We recommend consulting a licensed roofing contractor to evaluate and correct as needed. See Figure #5

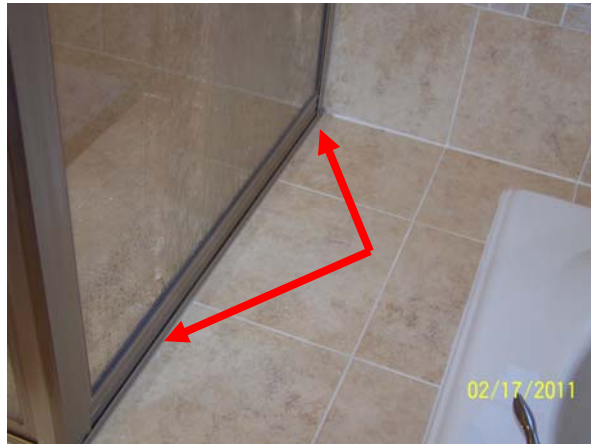
Figure #6

Water was leaking through the master bathroom shower glass wall. The leak was along the bottom ledge. Repairs are advised.

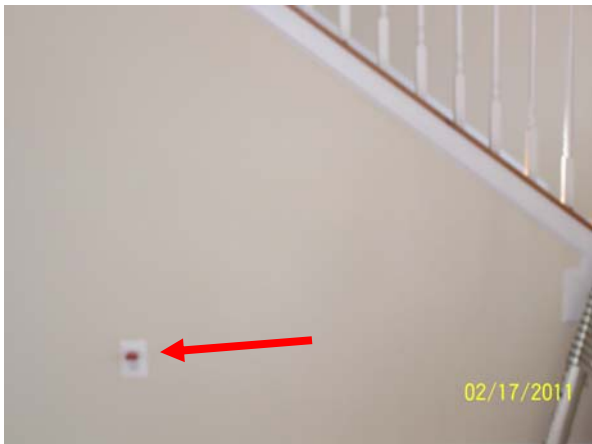
Figure #7

There was a nonfunctional electrical outlet in the foyer. We recommend consulting a licensed electrician for repairs.

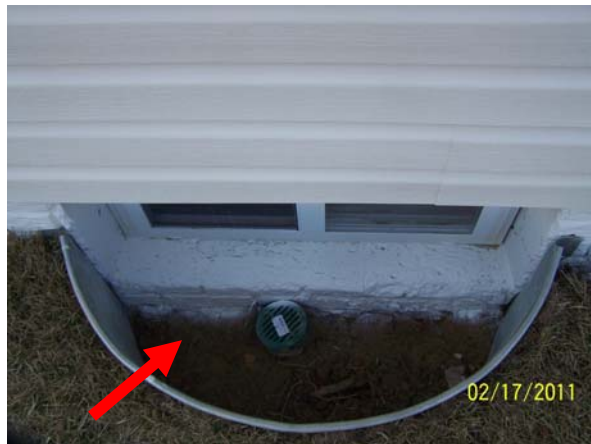
There was no gravel in the basement window wells. We recommend having gravel added if required.

- There was a missing light bulb in the utility room. We recommend installing a light bulb so the fixture can be tested for function.
- There was no gravel in the basement window wells. We recommend having gravel added if required. See Figure #8

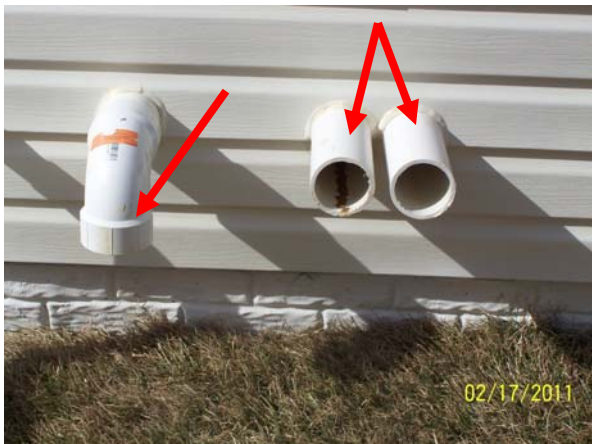
There was a radon mitigation pipe installed. The pipe stopped at knee level at the right exterior side of the home. Radon mitigation pipes should extend to above roof level. We recommend having the pipe properly installed.

The furnace intake and exhaust pipes were improperly installed. We recommend consulting a HVAC technician to properly install the furnace intake and exhaust

- The furnace intake and exhaust pipes were improperly installed. We recommend

consulting a HVAC technician to properly install the furnace intake and exhaust.
See Figure #9

- There was a radon mitigation pipe installed. The pipe stopped at knee level, on the right side of the home. Radon mitigation pipes should extend to above roof level. We recommend having the pipe properly installed. See Figure #9
- The utility room was not vented. We recommend having the room vented.
